Improving Pump Efficiency

Pump lining technology reduces friction and absorbs energy of cavitation bubbles.

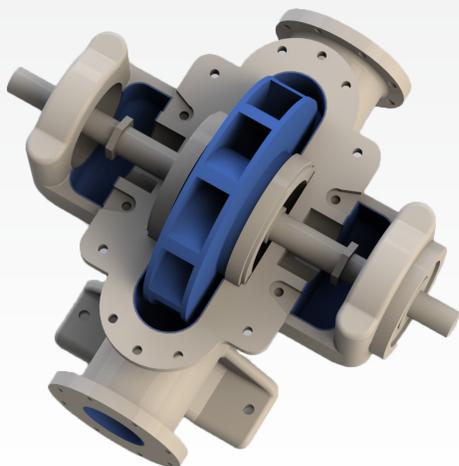
Additionally, replacement costs can be eliminated when damage is repaired and rebuilt using **MeCaFix 120** based metal repair as the base layer, overcoated with **MeCaWear 300**, which is a hybridized blend of polyurethane/epoxy ceramic coating for higher impact resistance.
